Town of Baldwin Stormwater Study

**TOWN OF BALDWIN
STORMWATER STUDY
(UPWP 5.18)**

Final Report

August 29, 2022

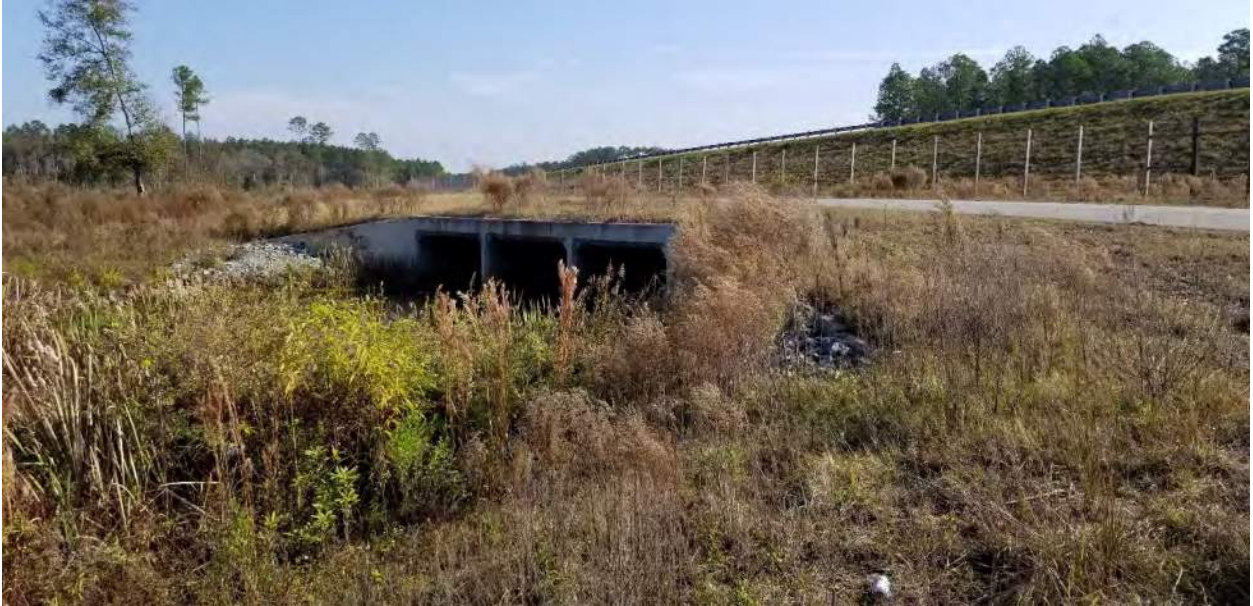
FDOT CD-6 view of downstream channel and culvert.

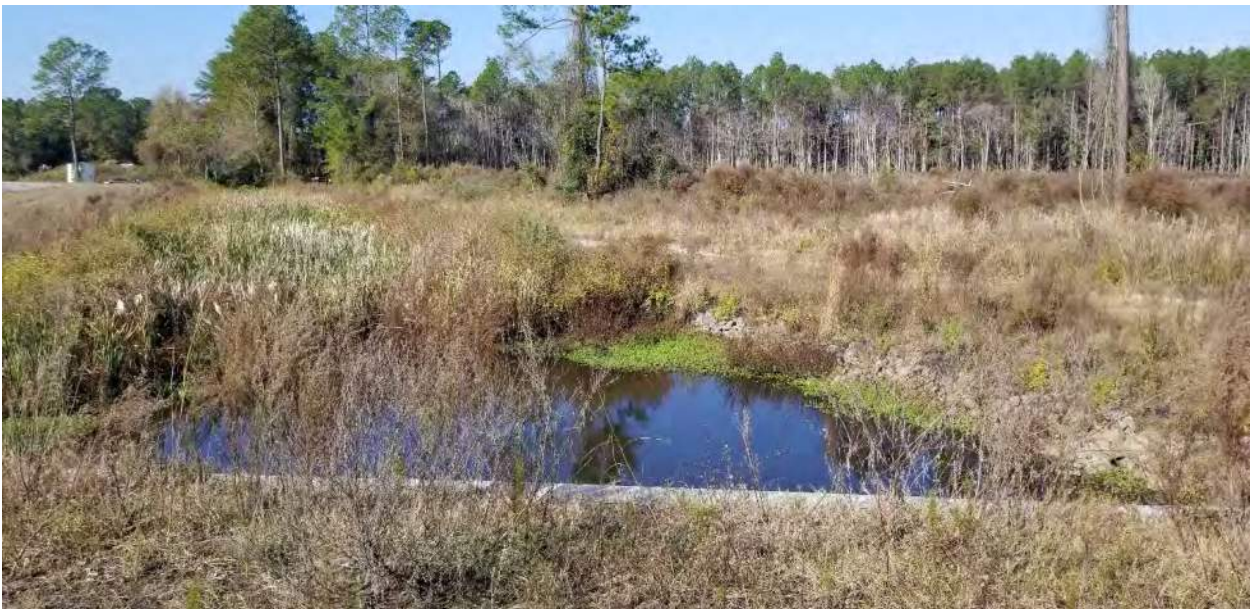
FDOT CD-6: view of downstream channel conditions.

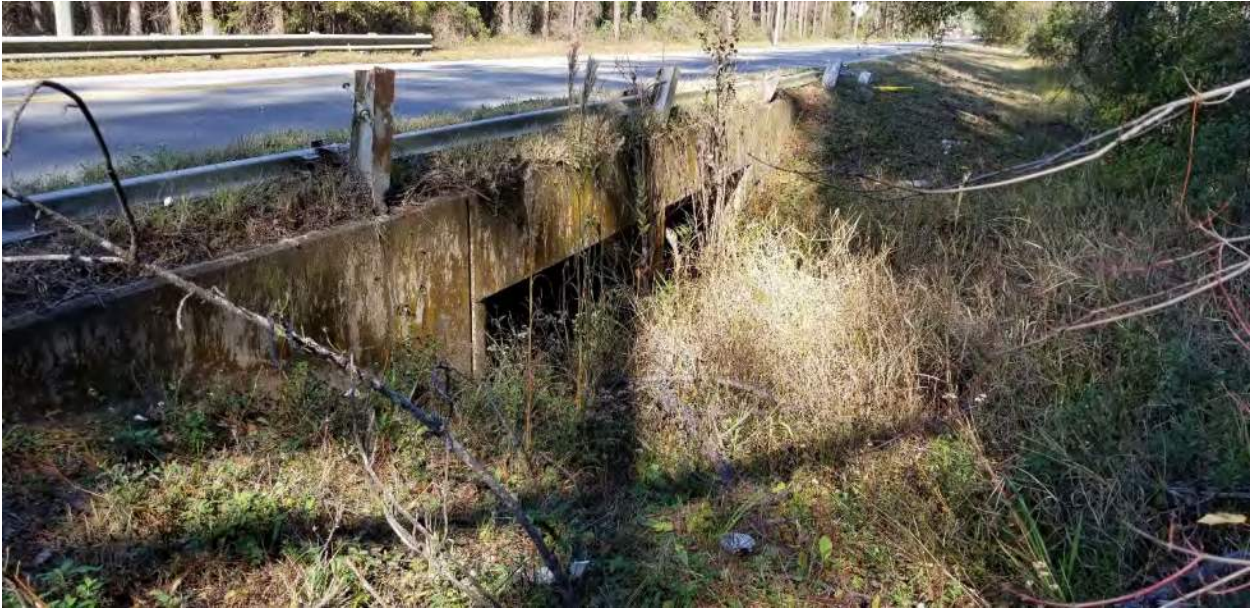
Existing culvert under Yellow Water Road (upstream).

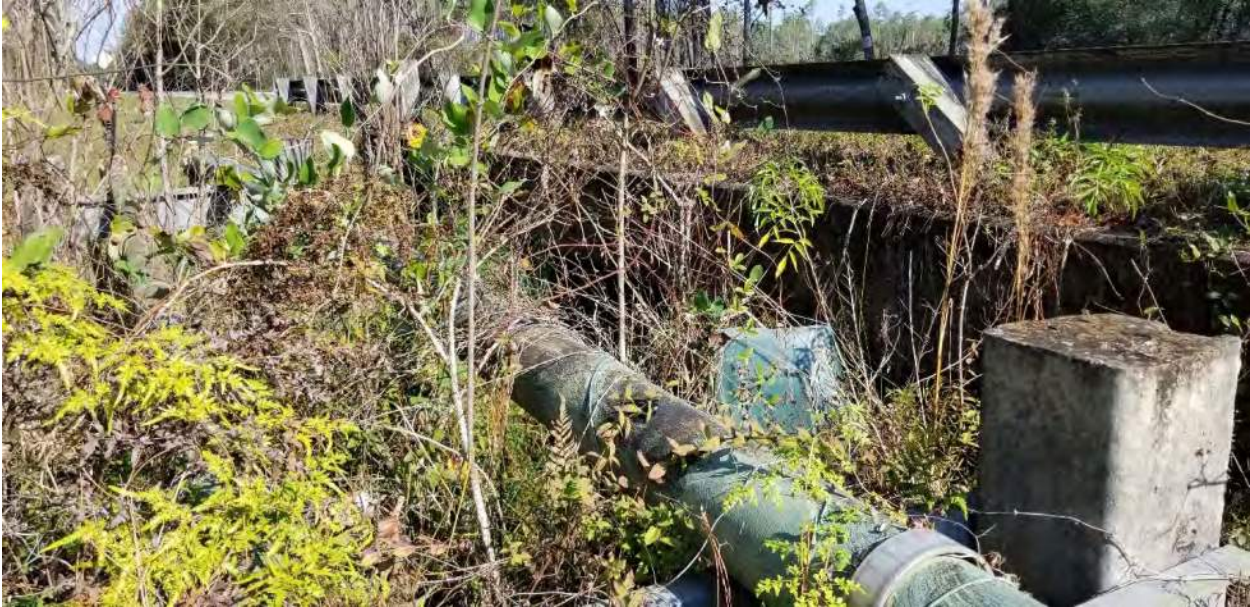
Existing culvert under Yellow Water Road with a view of downstream culvert channel conditions.

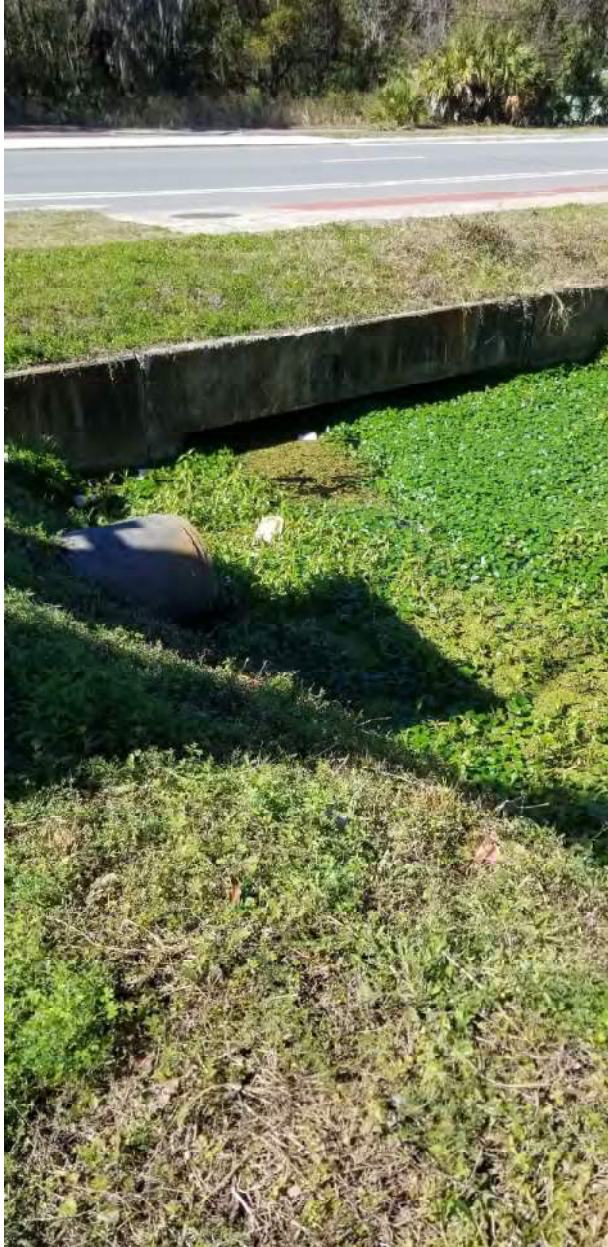
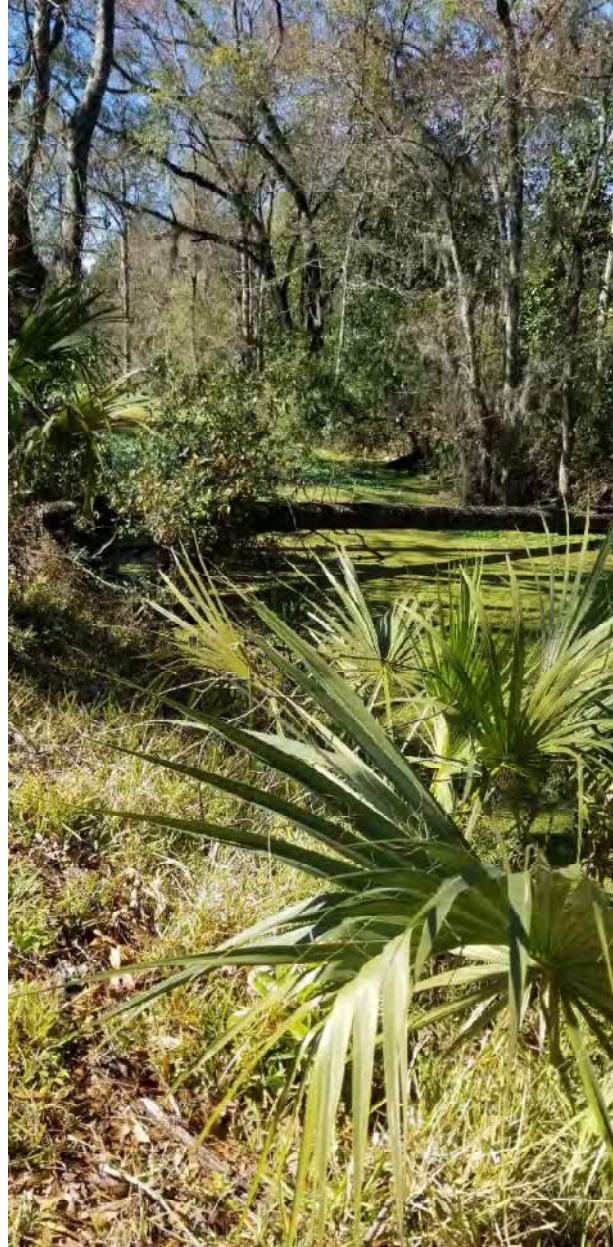
Priority #1

Main east-west ditch and culvert under US 301/ SR 200 that drains toward FDOT CD-2. The views are of the downstream channel conditions.

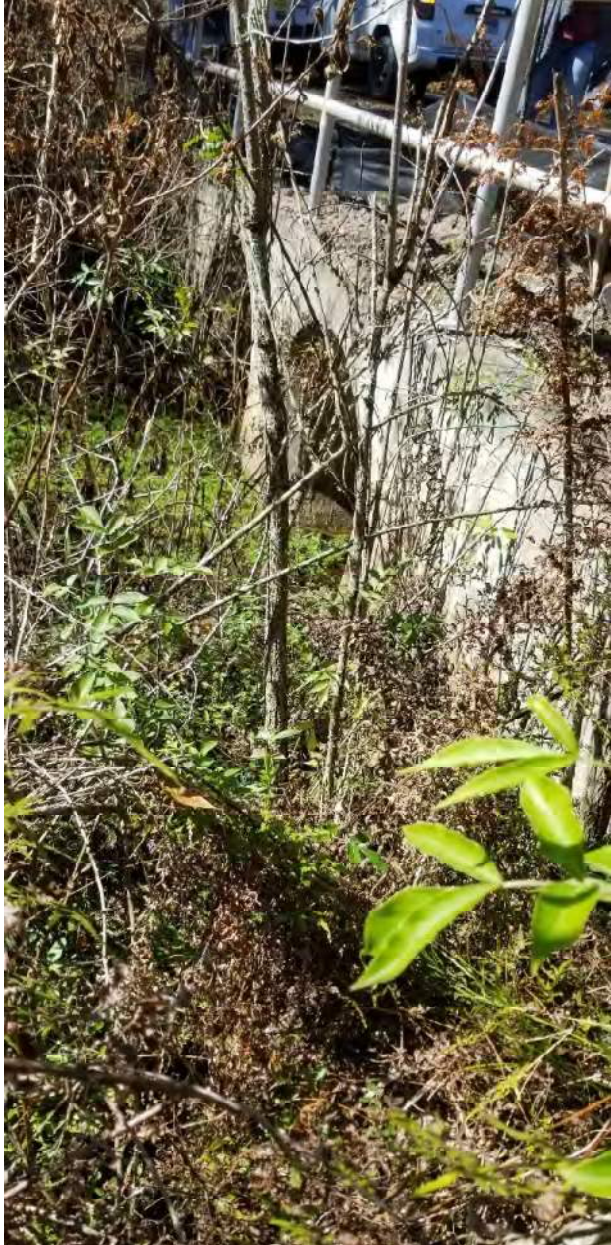
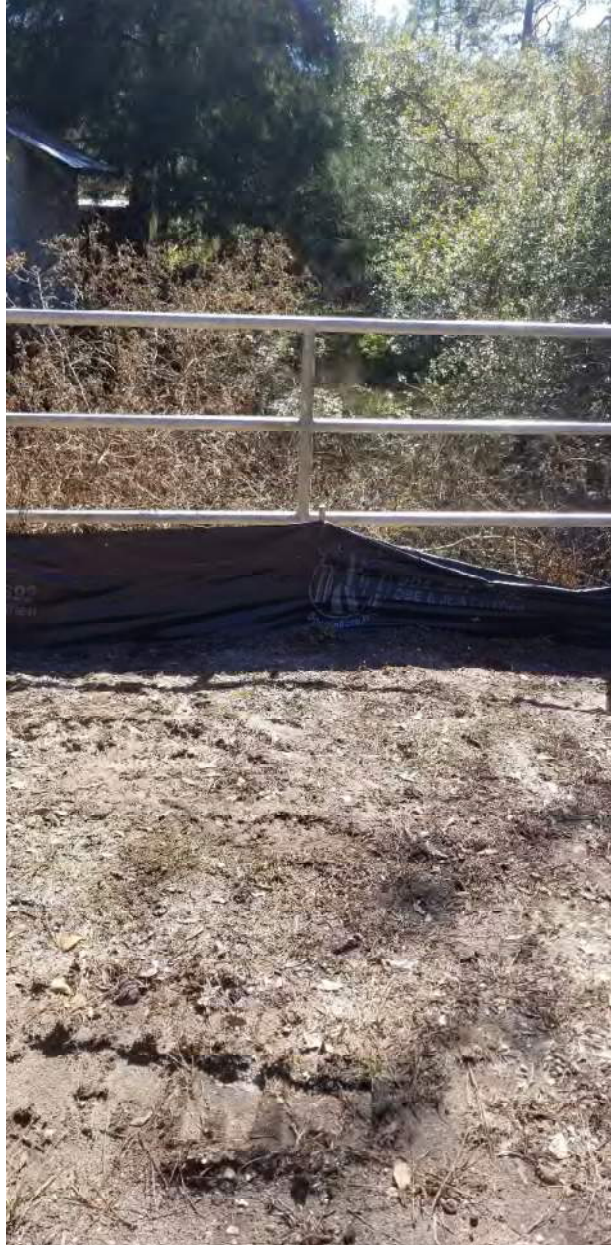
Priority #3

Culvert under Jacksonville-Baldwin Rail Trail (west of Baldwin Station/ Trailhead). View of downstream channel.

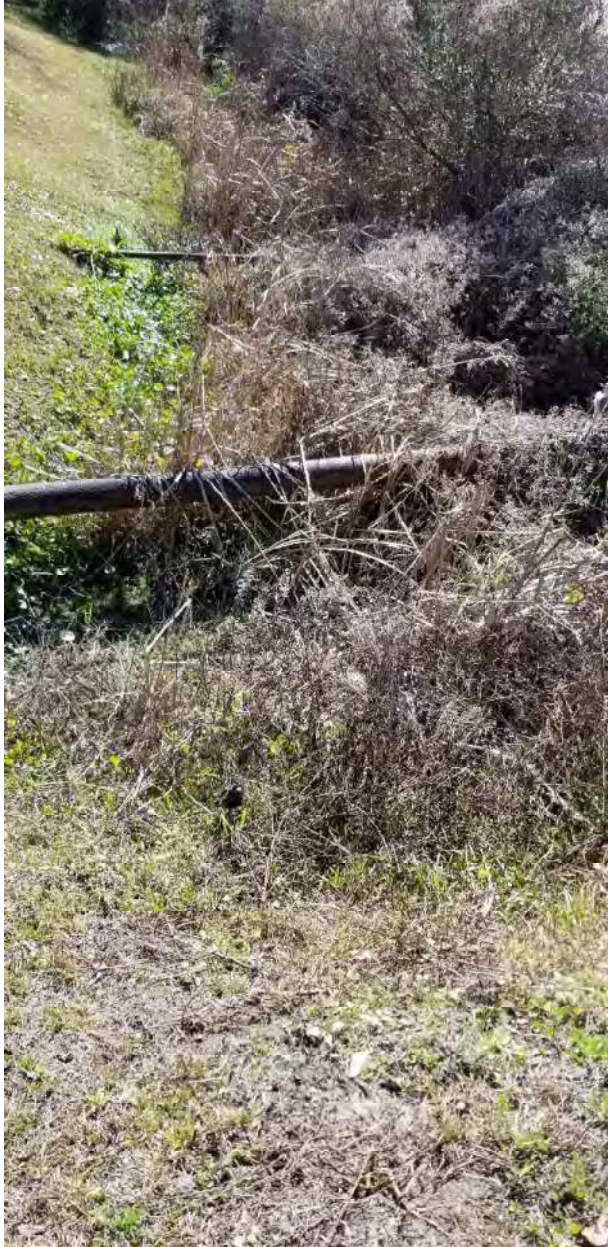
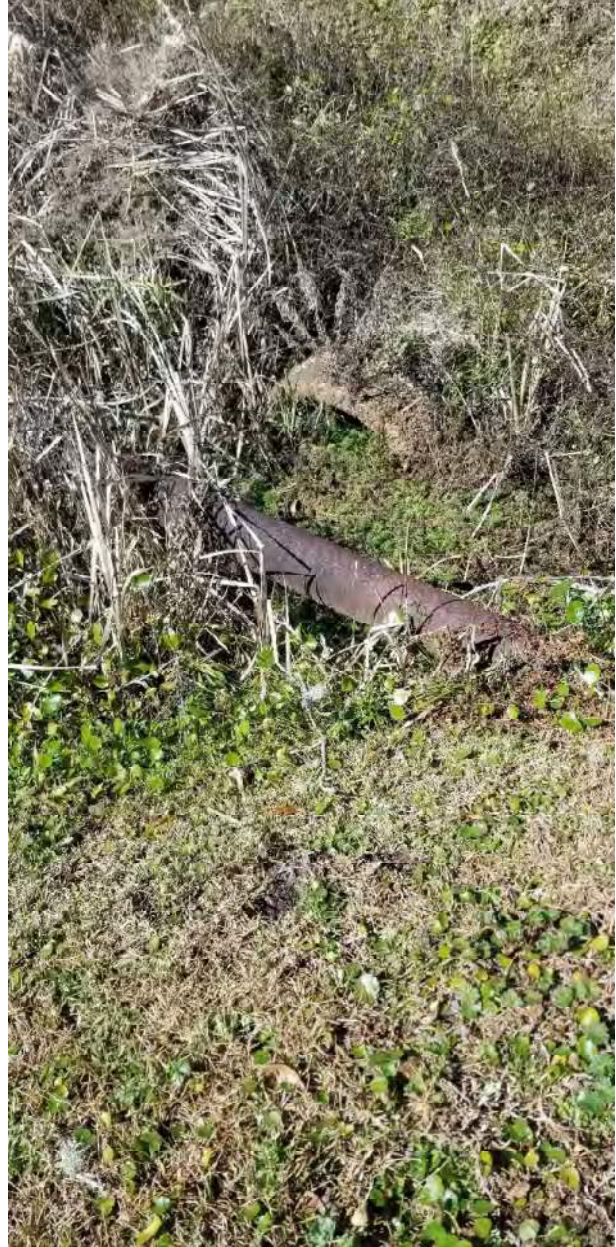
Priority #4

This photo was taken at the culvert under Jacksonville-Balwin Rail Trail at Lafayette Street. The view is looking south of the upstream channel conditions.
