## Duval Schools Walkability Study

North Florida Transportation Planning Organization

## ATKINS

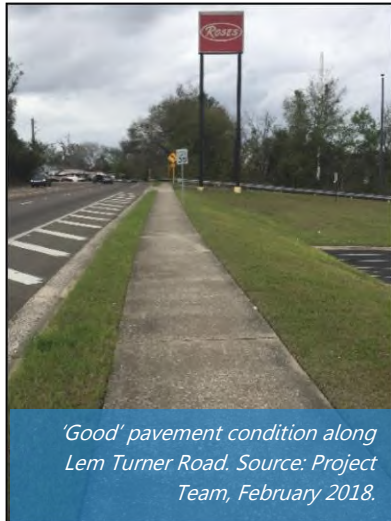
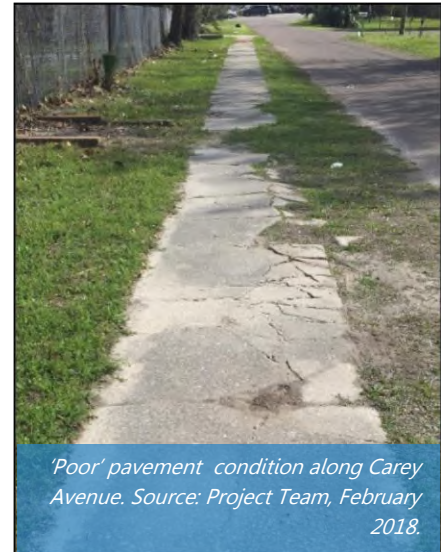
FIGURE 3-3 HENRY KITE SIDEWALK CONDITION

A majority of the sidewalks surveyed were determined to be either in Fair (42%) or Good (39%) condition. Less than 20% of the sidewalks were classified as Poor condition. The sidewalks in Poor condition were concentrated along Highland Avenue (which provides direct access to the school), 5<sup>th</sup> Avenue, and Basset Avenue.

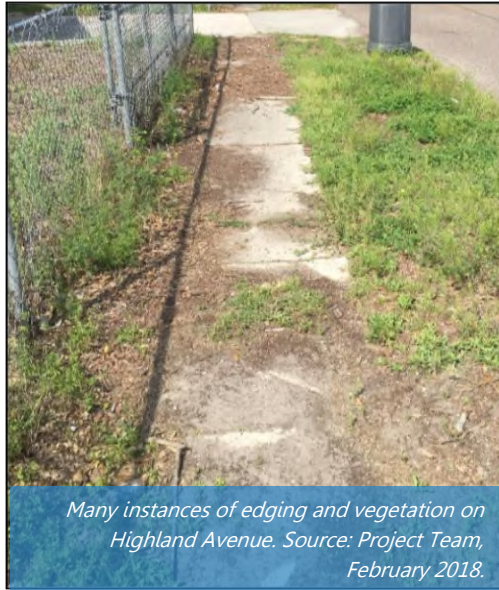
VEGETATION/MAINTENANCE

Over 75% of the sidewalks surveyed had minimal or few instances of sidewalk edging needs or vegetation encroachment. The areas with many instances were along Highland Avenue, the northern portion of Lem Turner Road, and 5th Avenue.

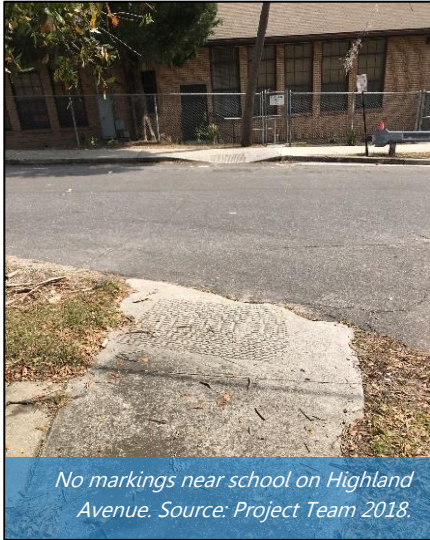
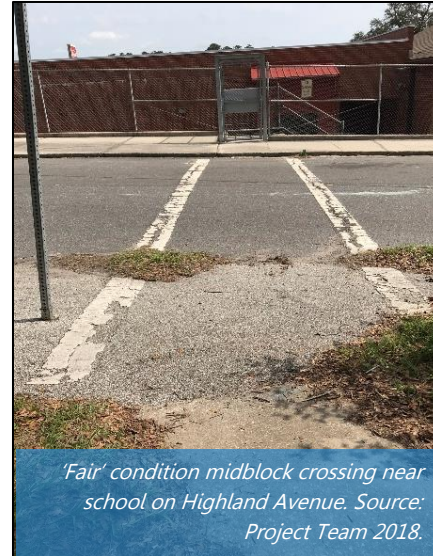
FIGURE 3-7 HENRY KITE CROSSWALK CONDITIONS

There were 11 marked crosswalks along the roadways surveyed. A majority of them were at intersections along Lem Turner Road, with the remaining along Soutel Drive and Ribault Avenue. There was one midblock crosswalk near the entrance of the school on Highland Avenue between 4<sup>th</sup> Avenue and 5<sup>th</sup> Avenue. About half of the crosswalk markings (6 of the 11 instances) are considered to be in Fair or Excellent condition. Five of the crosswalks have Poor marking conditions, three of which are located along Lem Turner Road south of Bassett Road.

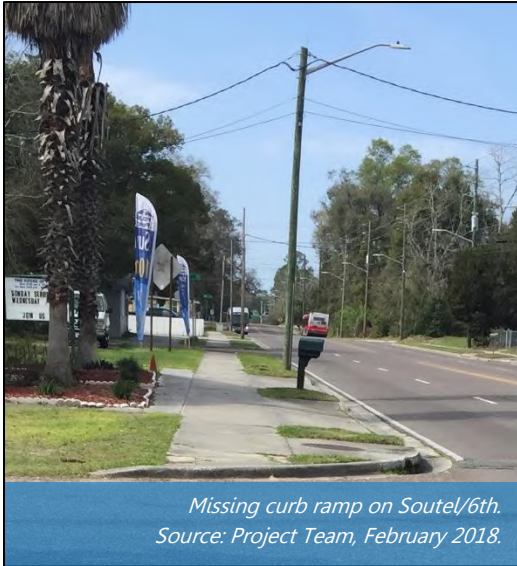
FIGURE 3-8 HENRY KITE CURB RAMPS

The majority of the curb ramps were in Good condition. However, several of the curb ramps adjacent to the school access were in Fair or Poor condition. Additionally, there were many missing curb ramps along the north side of Soutel Street.

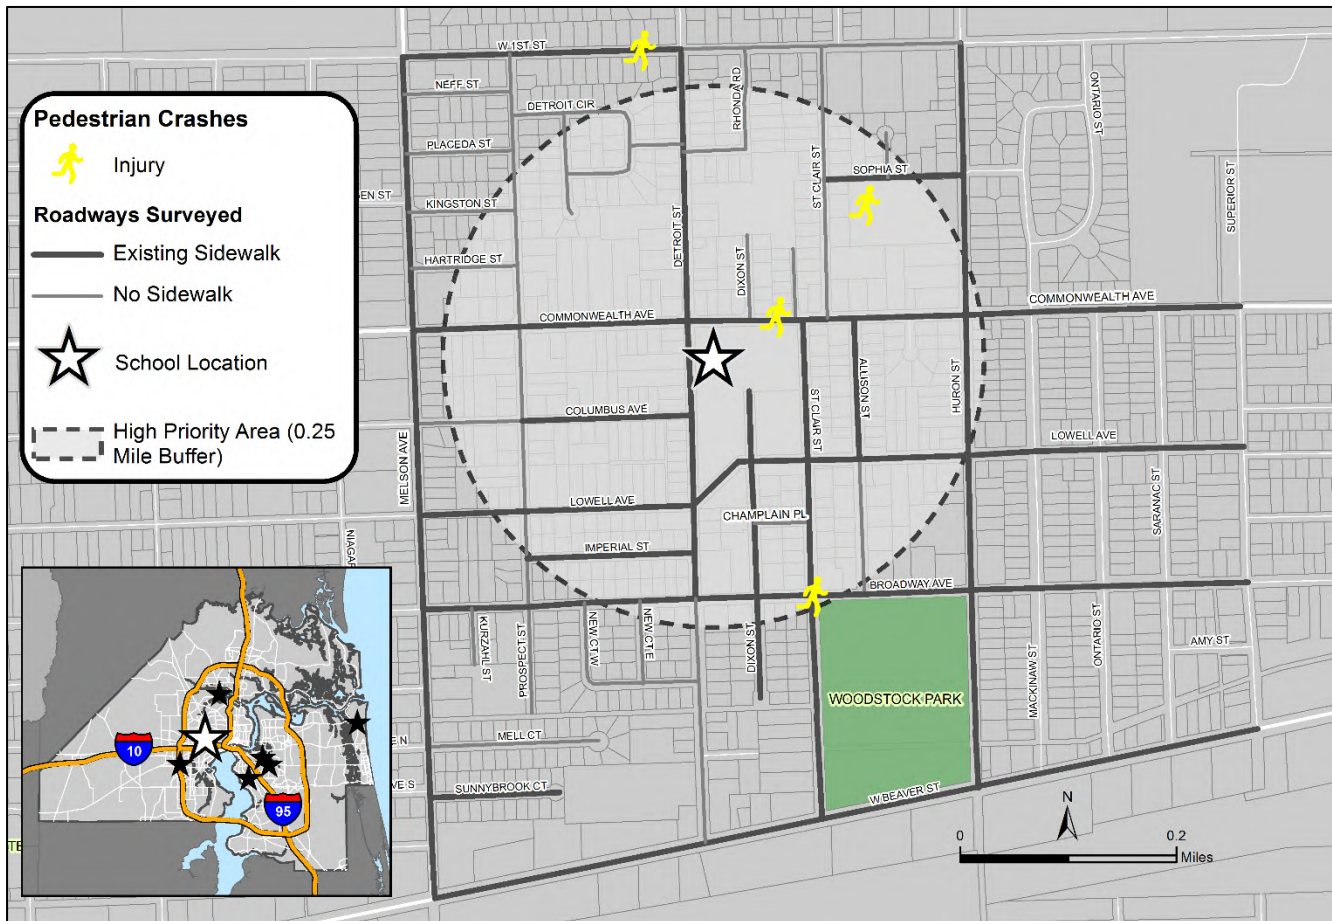
**FIGURE 3-14 ANNIE MORGAN PEDESTRIAN CRASHES**

There were 4 pedestrian crashes along the surveyed roads between January 2013 and January 2018. None of the crashes resulted in fatalities. 2 of the crashes occurred in the afternoon (between 1:00 PM and 4:00 PM), and the remaining 2 occurred in the 6:00 PM hour. The crash in 2014 occurred near the entrance of the school along Commonwealth Avenue. The crash locations are displayed in **Figure 3-14** and detailed in the table below. The full crash data is provided in **Appendix A**.

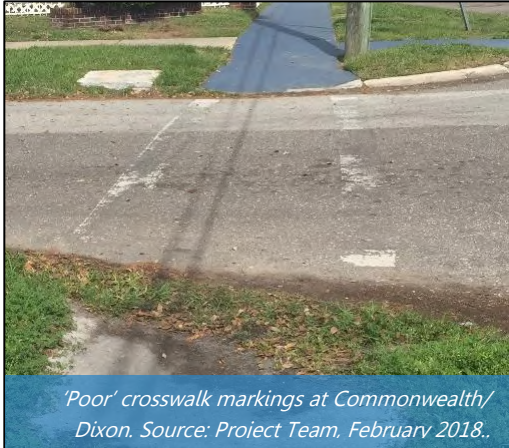
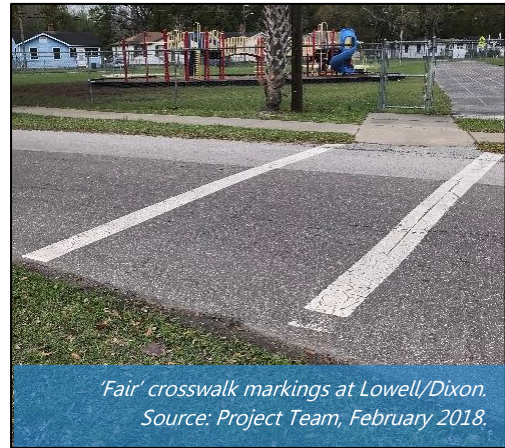
FIGURE 3-15 ANNIE MORGAN CROSSWALK CONDITIONS

There were 8 marked crosswalks along the roadways reviewed. A majority of were along Commonwealth Avenue, with the remaining along Beaver Street and Lowell Avenue. Most of the crosswalk markings (6 of the 8 instances) were considered to be in Fair or Good condition. The two crosswalks with Poor marking condition were located at Commonwealth Avenue/Dixon Street and Beaver Street/Melson Avenue.

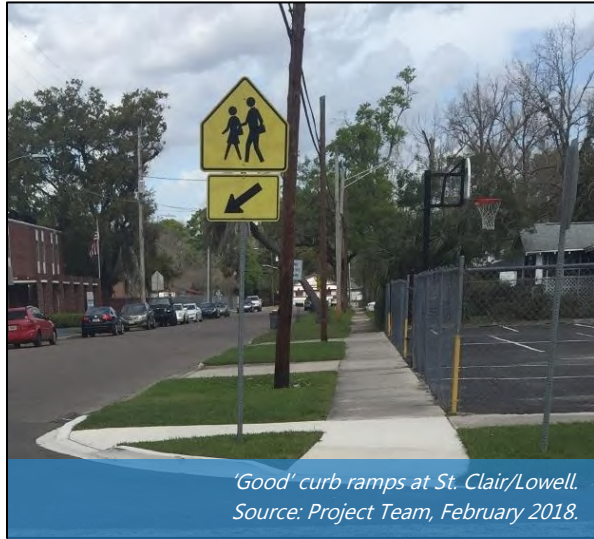
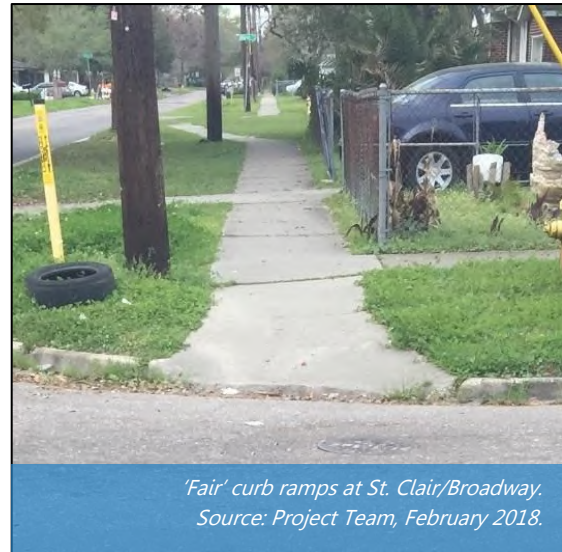
FIGURE 3-16 ANNIE MORGAN CURB RAMPS

The majority of the curb ramps were in Good or Fair condition. There were no Poor curb ramps directly adjacent to the school. Several of the crossings along Melson Avenue had missing curb ramps.

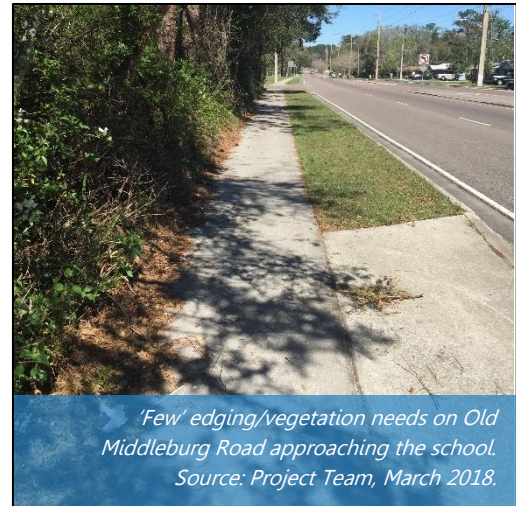
FIGURE 3-20 ED WHITE VEGETATION AND MAINTENANCE

About 33% of the sidewalks had many or few instances of edging and vegetation issues. Memorial Park Road south of Lenox Avenue had the majority of the 'Many' instances. The sidewalks along the arterials (Normandy Boulevard and Lane Avenue) generally had minimal vegetation maintenance issues.

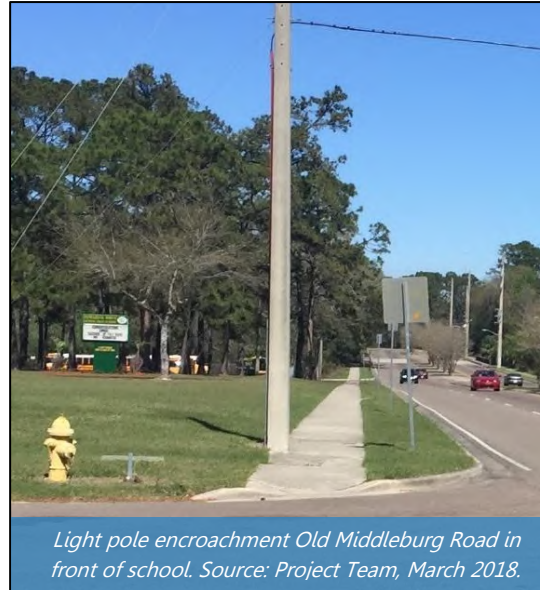
FIGURE 3-21 ED WHITE OBSTRUCTIONS

A majority of the sidewalks (75%) had minimal obstructions. The sidewalks with Few obstructions are located along Old Middleburg Road, Fouraker Road, Lenox Avenue, and Lane Avenue. These sidewalks typically had light pole encroachment, tree roots, or benches on the sidewalk.

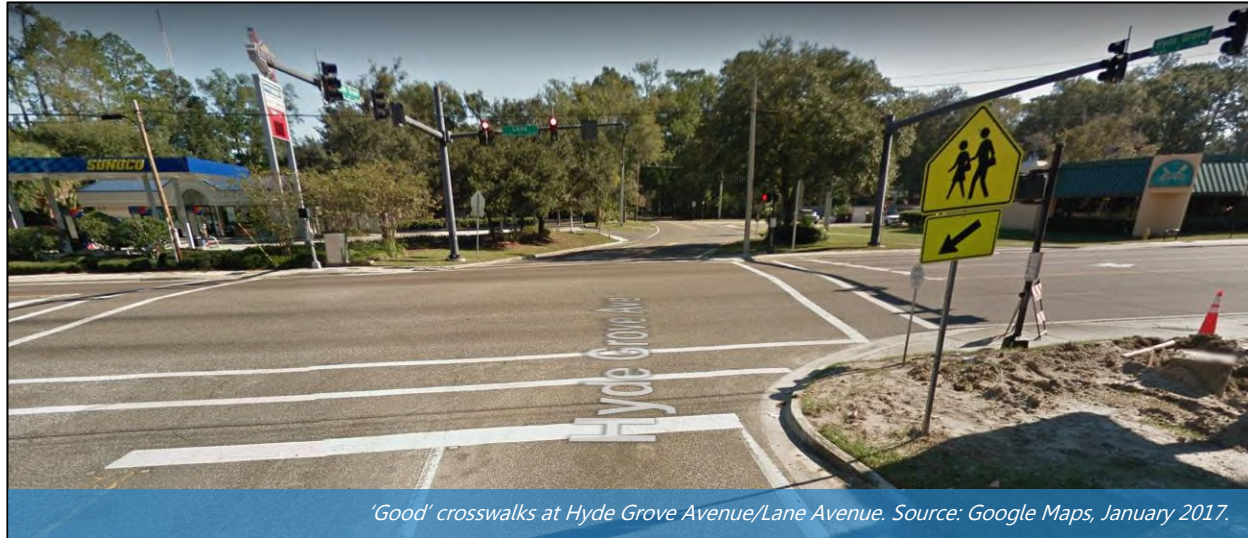
FIGURE 3-23 ED WHITE CROSSWALK CONDITIONS

There were 23 marked crosswalks along the roadways reviewed. About half of the marked crosswalks were located across neighborhood entrance roads along Foraker Road, most of which were in Poor condition. The crosswalks along Normandy and Lane Avenue vary from Good to Poor condition. **There were no marked crosswalks within 0.5 miles of the school.**

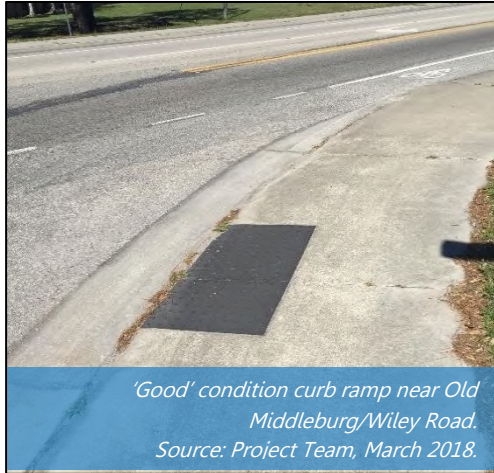
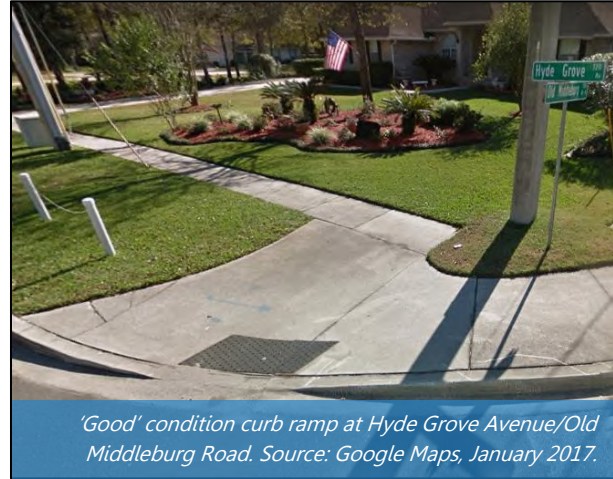
FIGURE 3-24 ED WHITE CURB RAMP

All of the curb ramps observed were considered to be in Good condition, with the exception of one curb ramp on Hyde Grove Road and Navaho Road. Additionally, there were few missing curb ramps along the roads surveyed.

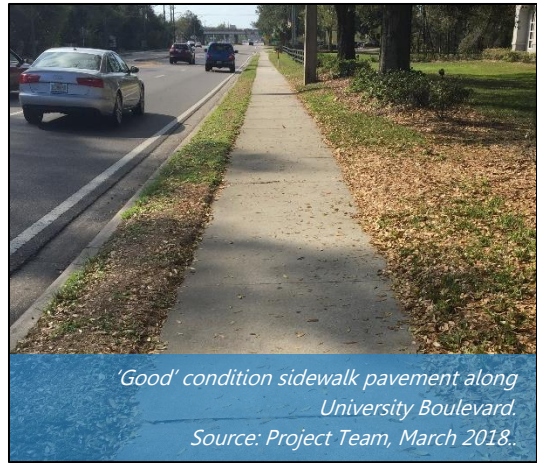
FIGURE 3-27 LOVE GROVE SIDEWALK CONDITION

A majority of the sidewalks were rated as Good condition (73%), which includes the length of the sidewalk reviewed for Atlantic and Beach Boulevards. The remaining sidewalks (27%) were rated as Fair condition, including portions of Bartram Road and the northern segment of University Boulevard. No sidewalks were considered to be in Poor condition.

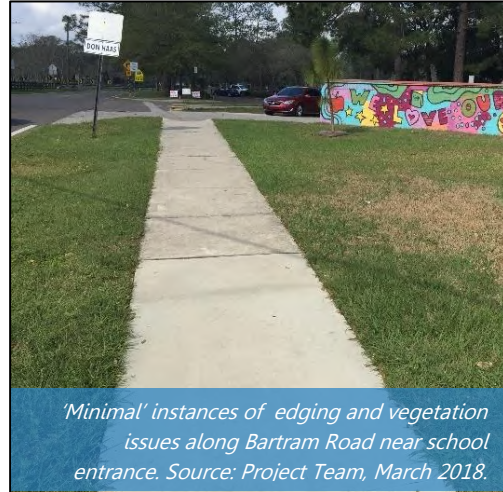
FIGURE 3-28 LOVE GROVE VEGETATION AND MAINTENANCE

All of the sidewalks had minimal or few instances of edging and vegetation encroachment. Similar to pavement condition, sections of Bartram Road and University Boulevard had Few instances of edging and vegetation issues, along with a section on Atlantic Boulevard. The sidewalks closest to the school had minimal edging and vegetation encroachment.

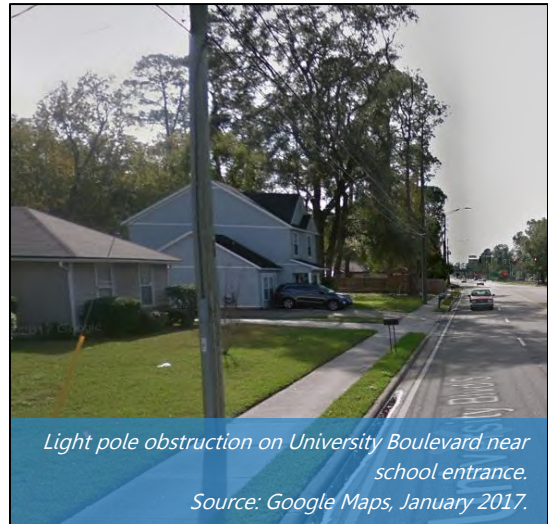
FIGURE 3-29 LOVE GROVE OBSTRUCTIONS

About half of the sidewalks (47%) had few instances of non-vegetative sidewalk obstructions. These instances were primarily sidewalk light poles and benches encroaching the walkway along Atlantic and Beach Boulevards.

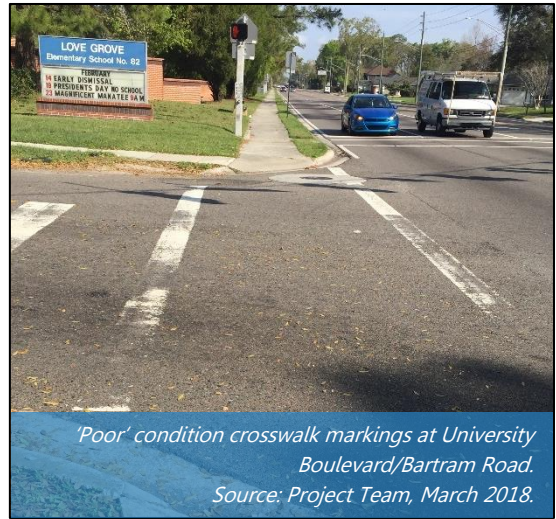
**FIGURE 3-31 LOVE GROVE CROSSWALK CONDITIONS**

There were 30 marked crosswalks along the roads surveyed, 3 of which were within 0.25 miles of the school. The 2 marked crosswalks closest to the school were in Fair and Poor condition. For the most part, the marked crossings along two of the arterials (Atlantic and Beach Boulevards) were in Good condition. However, 2 of the 5 marked crosswalks along University Boulevard were in Poor condition.

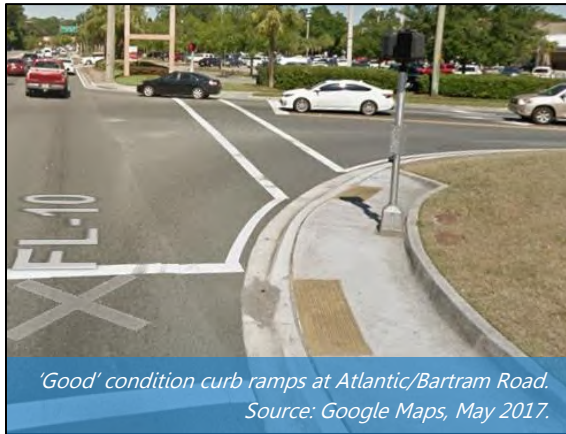
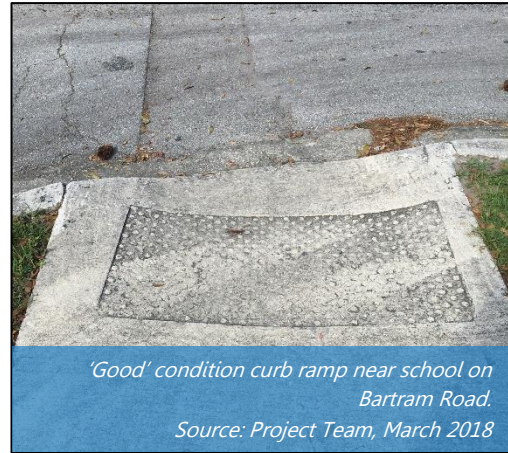
FIGURE 3-32 LOVE GROVE CURB RAMPS

All curb ramps surveyed were considered to be in 'Good' condition. Many of the curb ramps were brand new, especially along Beach Boulevard.

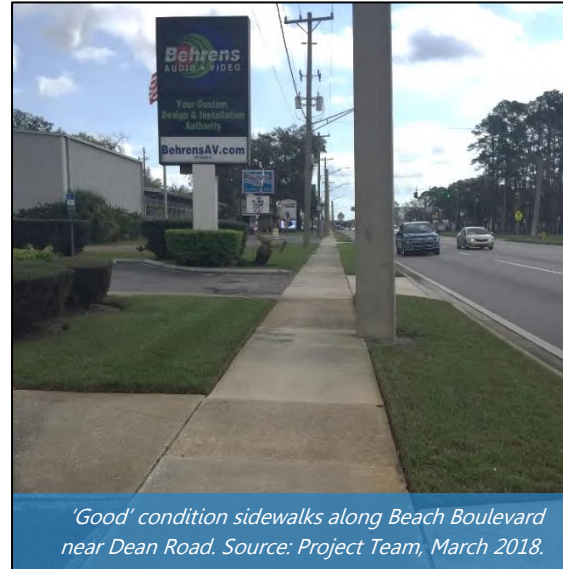
FIGURE 3-35 HOGAN SPRING SIDEWALK CONDITIONS

A majority of the sidewalks were considered to be in Good or Fair condition (91%). Less than 10% of the sidewalks were in Poor condition. The Poor condition sidewalks were primarily located along local roads (South Road, West Road), with small sections along collectors (Dean Road, Hogan Road).

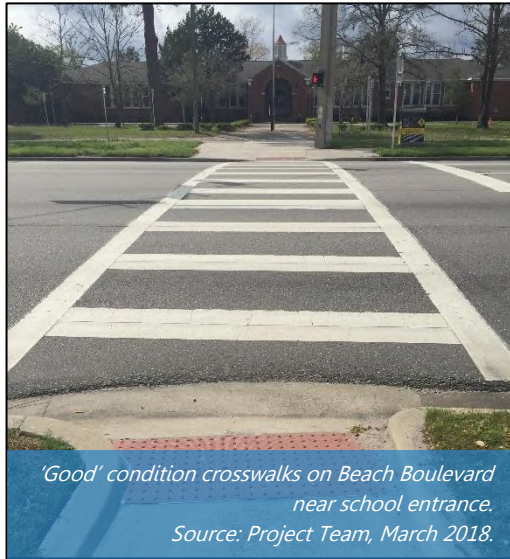
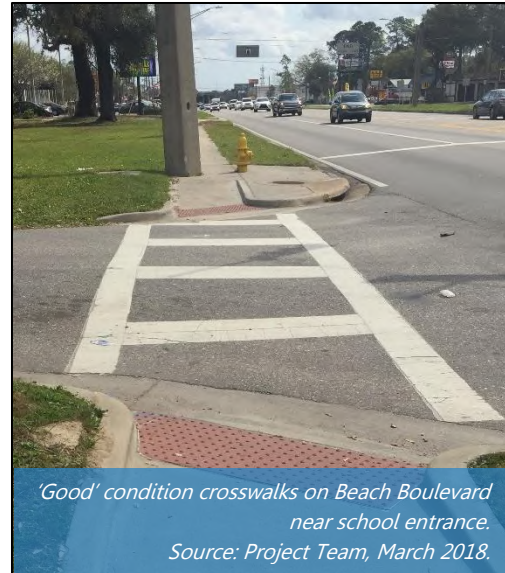
FIGURE 3-39 HOGAN SPRING CROSSWALKS

There were 26 marked crosswalks along the roads surveyed, 7 of which were within 0.25 miles of the school. All of the crosswalk markings surveyed were considered to be in Good condition. Additionally, the crosswalk in front of the school signaled and the markings notably visible.

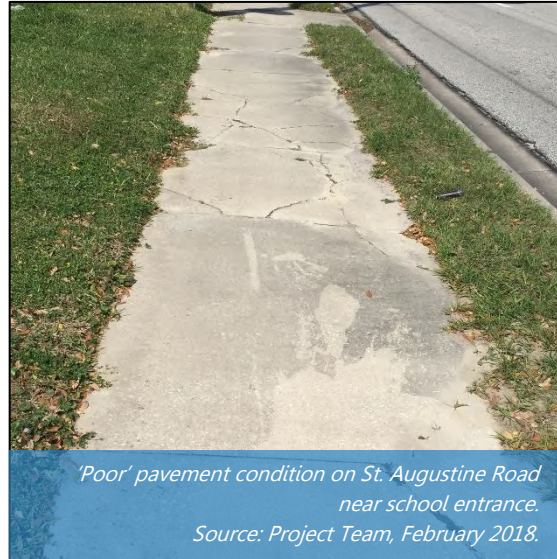
FIGURE 3-43 SAN JOSE SIDEWALK CONDITIONS

Only 1% of the sidewalks were rated as Poor condition. This small section of Poor sidewalk is located on Saint Augustine Road near the school entrance. Approximately 67% of the sidewalks were rated as Good condition, and 32% were in Fair condition.

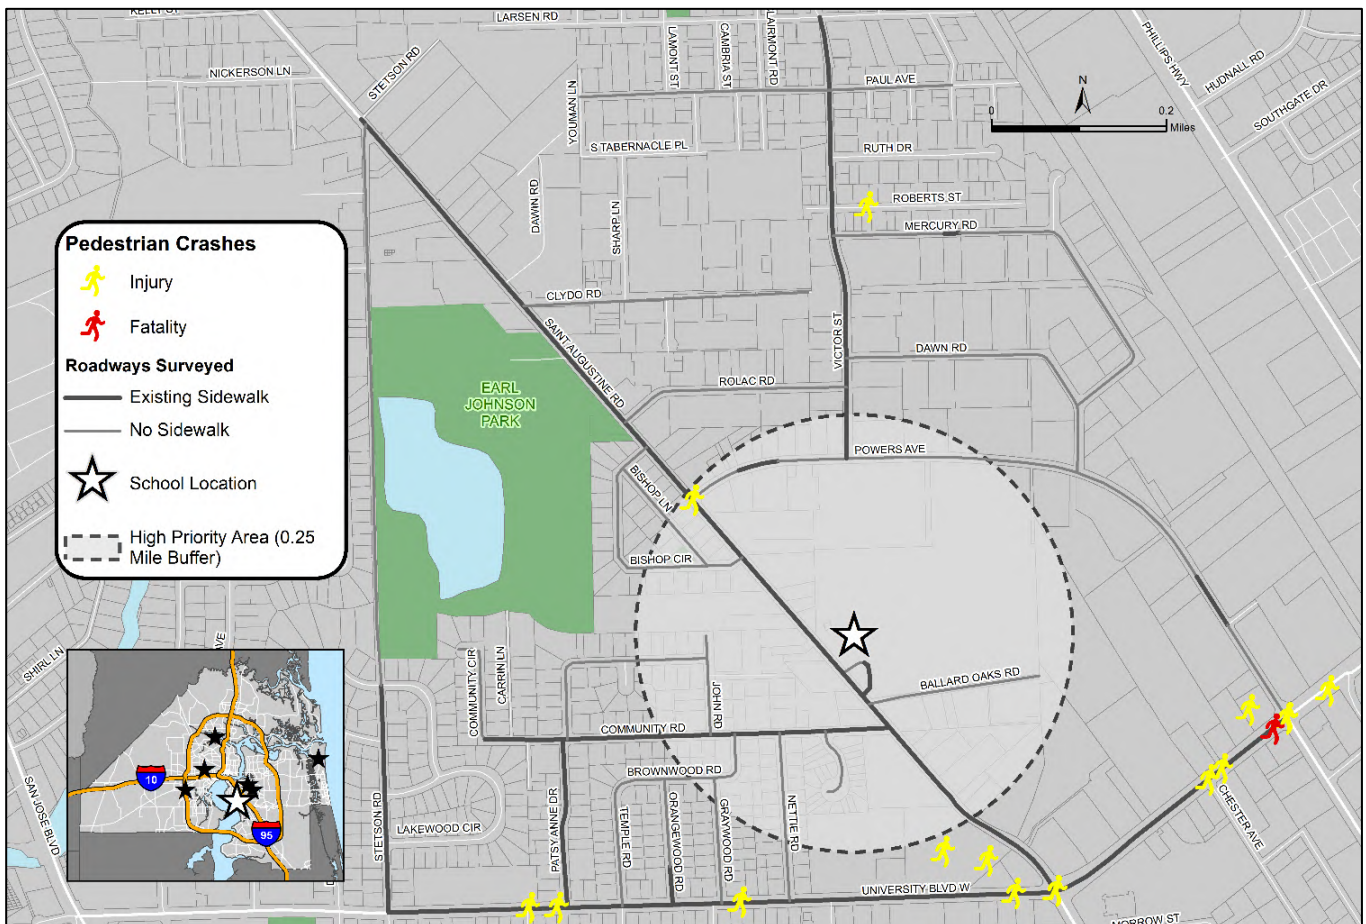
**FIGURE 3-46 SAN JOSE PEDESTRIAN CRASHES**

- ◆ There were 20 pedestrian crashes between January 2013 and January 2018.
- ◆ A majority of the crashes occurred along University Boulevard, with concentrations near University Boulevard/Chester Avenue and University Boulevard/Powers Road.
- ◆ 1 crash occurred within 0.25 miles of the school at the intersection of St. Augustine Road and Powers Road in December 2017 at 8:45 AM during wet road conditions.
- ◆ 1 pedestrian crash resulted in a fatality on University Boulevard west of the Powers Road intersection. The crash occurred in December 2015 at 7:35 PM.
- ◆ 2 of the crashes occurred before 12:00 PM. A majority of the crashes occurred between 4:00 PM and 11:00 PM.

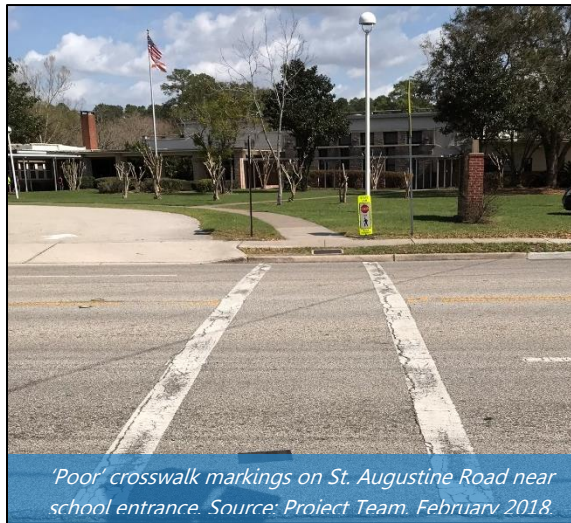
FIGURE 3-47 SAN JOSE CROSSWALK CONDITIONS

There were 7 marked crosswalks along the roads surveyed, 4 of which were within 0.25 miles of the school. All 4 crosswalks near the school were considered to be in Poor condition. The remaining 3 marked crosswalks were along University Boulevard and varied in condition.

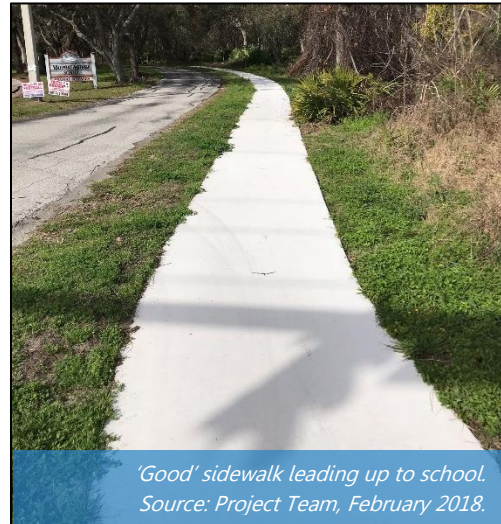
FIGURE 3-51 MAYPORT SIDEWALK CONDITION

Nearly all of the sidewalks (97%) were rated as Good condition. The remaining 3% were in Fair condition, which are located along Gavagan Road and Old Mayport Road. The sidewalks leading up to the school appeared to be recently updated.

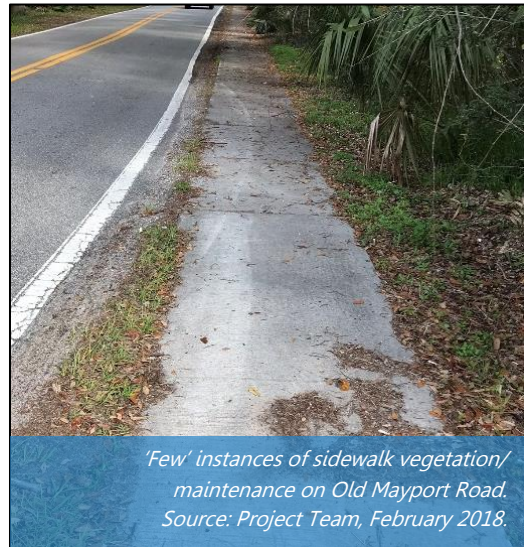
FIGURE 3-52 MAYPORT VEGETATION AND MAINTENANCE

93% of the sidewalks had minimal instances of edging and vegetation issues. Segments of Gavagan road, Old Mayport Road, and Renault Drive had few instances of edging and vegetation encroachment.

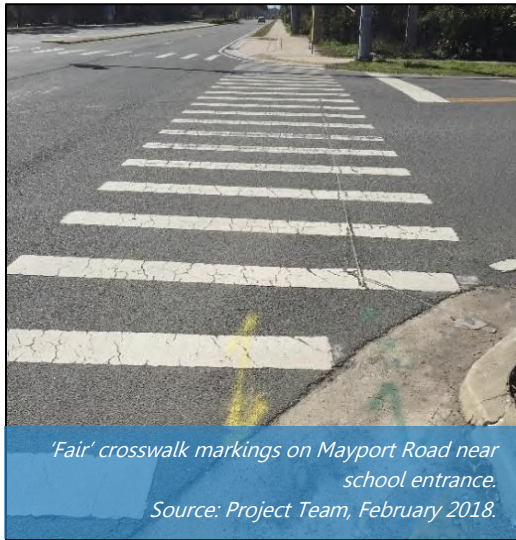
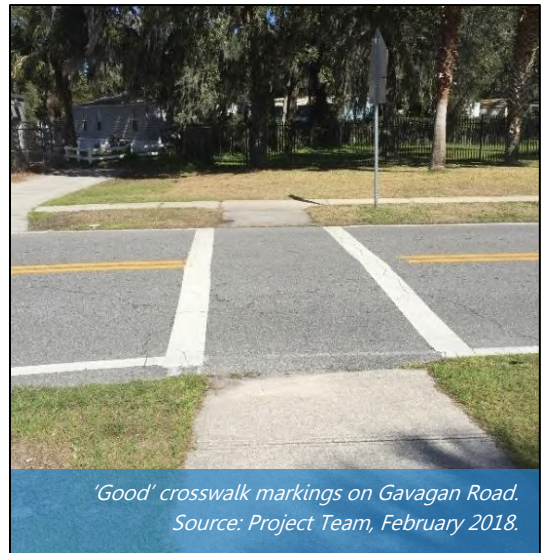
**FIGURE 3-55 MAYPORT CROSSWALKS**

There were 19 marked crosswalks along the roads surveyed, 3 of which were within 0.25 miles of the school. All crosswalks surveyed were considered to be in Good or Fair condition. Some of the crosswalks near the major intersections (Wonderwood/A1A and A1A/Mayport Road) appeared to be recently improved.

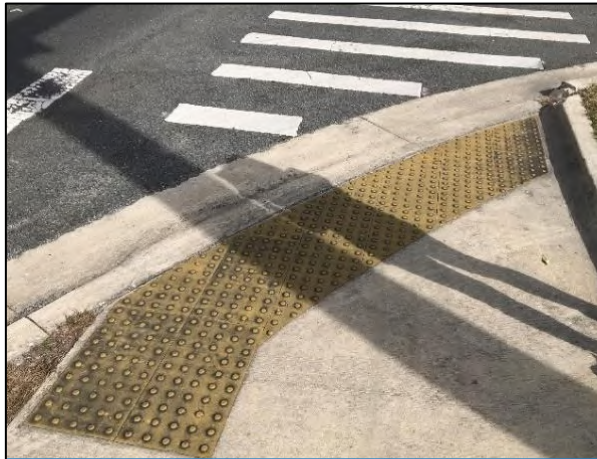
'Good' curb ramp at SR A1A/Mayport Road.  
Source: Project Team, February 2018.

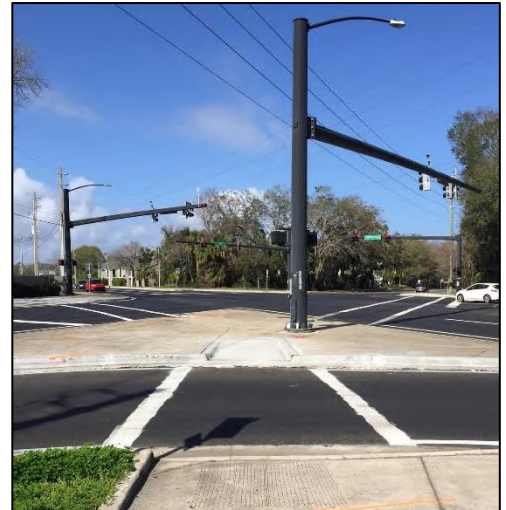
**FIGURE 3-56 MAYPORT CURB RAMPS**

All curb ramps surveyed were considered to be in 'Good' or 'Fair' condition and ADA compliant.

'Good' curb ramp at SR A1A/Wonderwood.  
Source: Project Team, February 2018.
