Town of Baldwin Stormwater Study

**TOWN OF BALDWIN
STORMWATER STUDY
(UPWP 5.18)**

Final Report

August 29, 2022

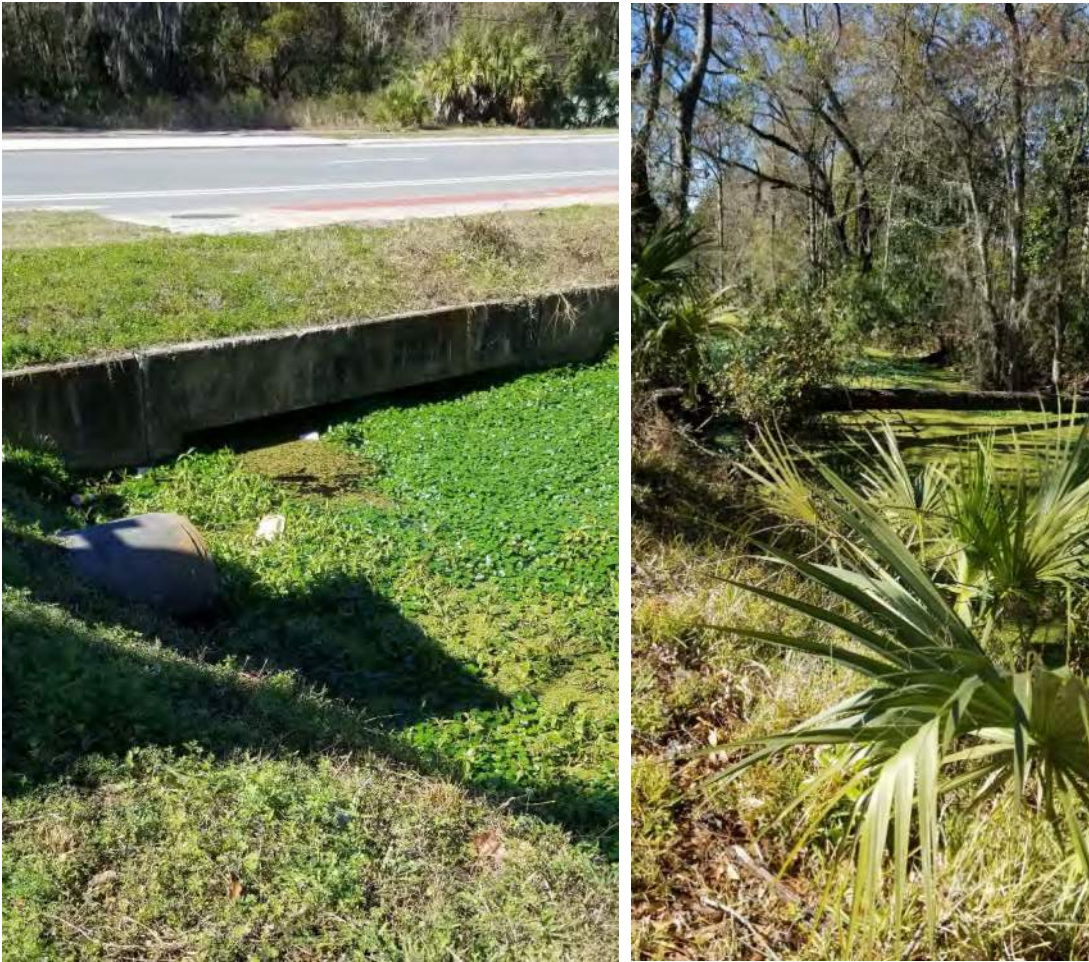
View of US 301 culvert outfall. The water surface elevation in the downstream channel is near the culvert top during a dry period. Note the aquatic vegetation growing on the water surface.

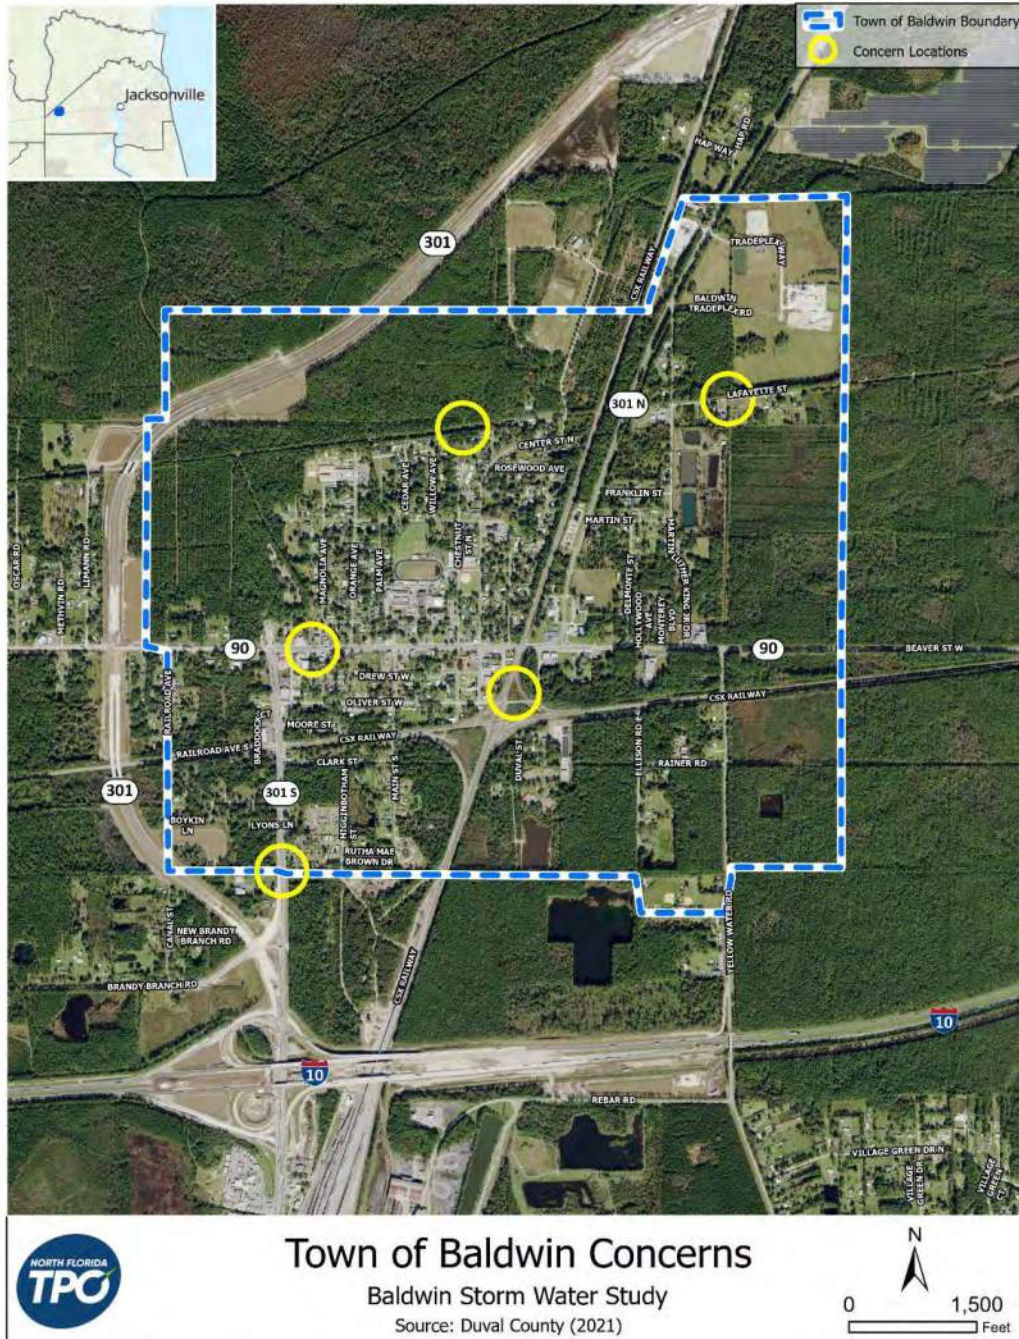
Figure 2. Town of Baldwin Concerns

A follow-up field meeting was held with Mayor Sean Lynch. Mayor Lynch also showed members of the study team problematic locations. The first was the culvert under US 301 located east of US 301/SR 201/Baldwin Bypass. Mayor Lynch indicated the biggest problem is the Town's inability to maintain the outfall due to lack of access. Maintenance staff frequently must remove beaver dams in this ditch. The site visits also included the CSX pond located within the track interchange. The pond and outfall pipe are unmaintained, which results in flooding of the ditch back onto Duval Street. Figure 2 represents the concerns observed during field meetings.

A lengthy discussion was held with Mayor Lynch on the benefits of potential improvements. The options discussed included new stormwater ponds and improved maintenance of the outfalls. Mayor Lynch indicated that the Town had no property or money to purchase pond sites and felt that the Town would benefit most by finding ways to coordinate the outfall maintenance with private property owners and the infrastructure stakeholders (FDOT and CSX). Neither the Town nor neighboring stakeholders have drainage easement rights to work beyond the public right-of-way. In addition, the conveyance capacity is controlled and impacted by downstream conditions. Field photos have been provided in Appendix B.

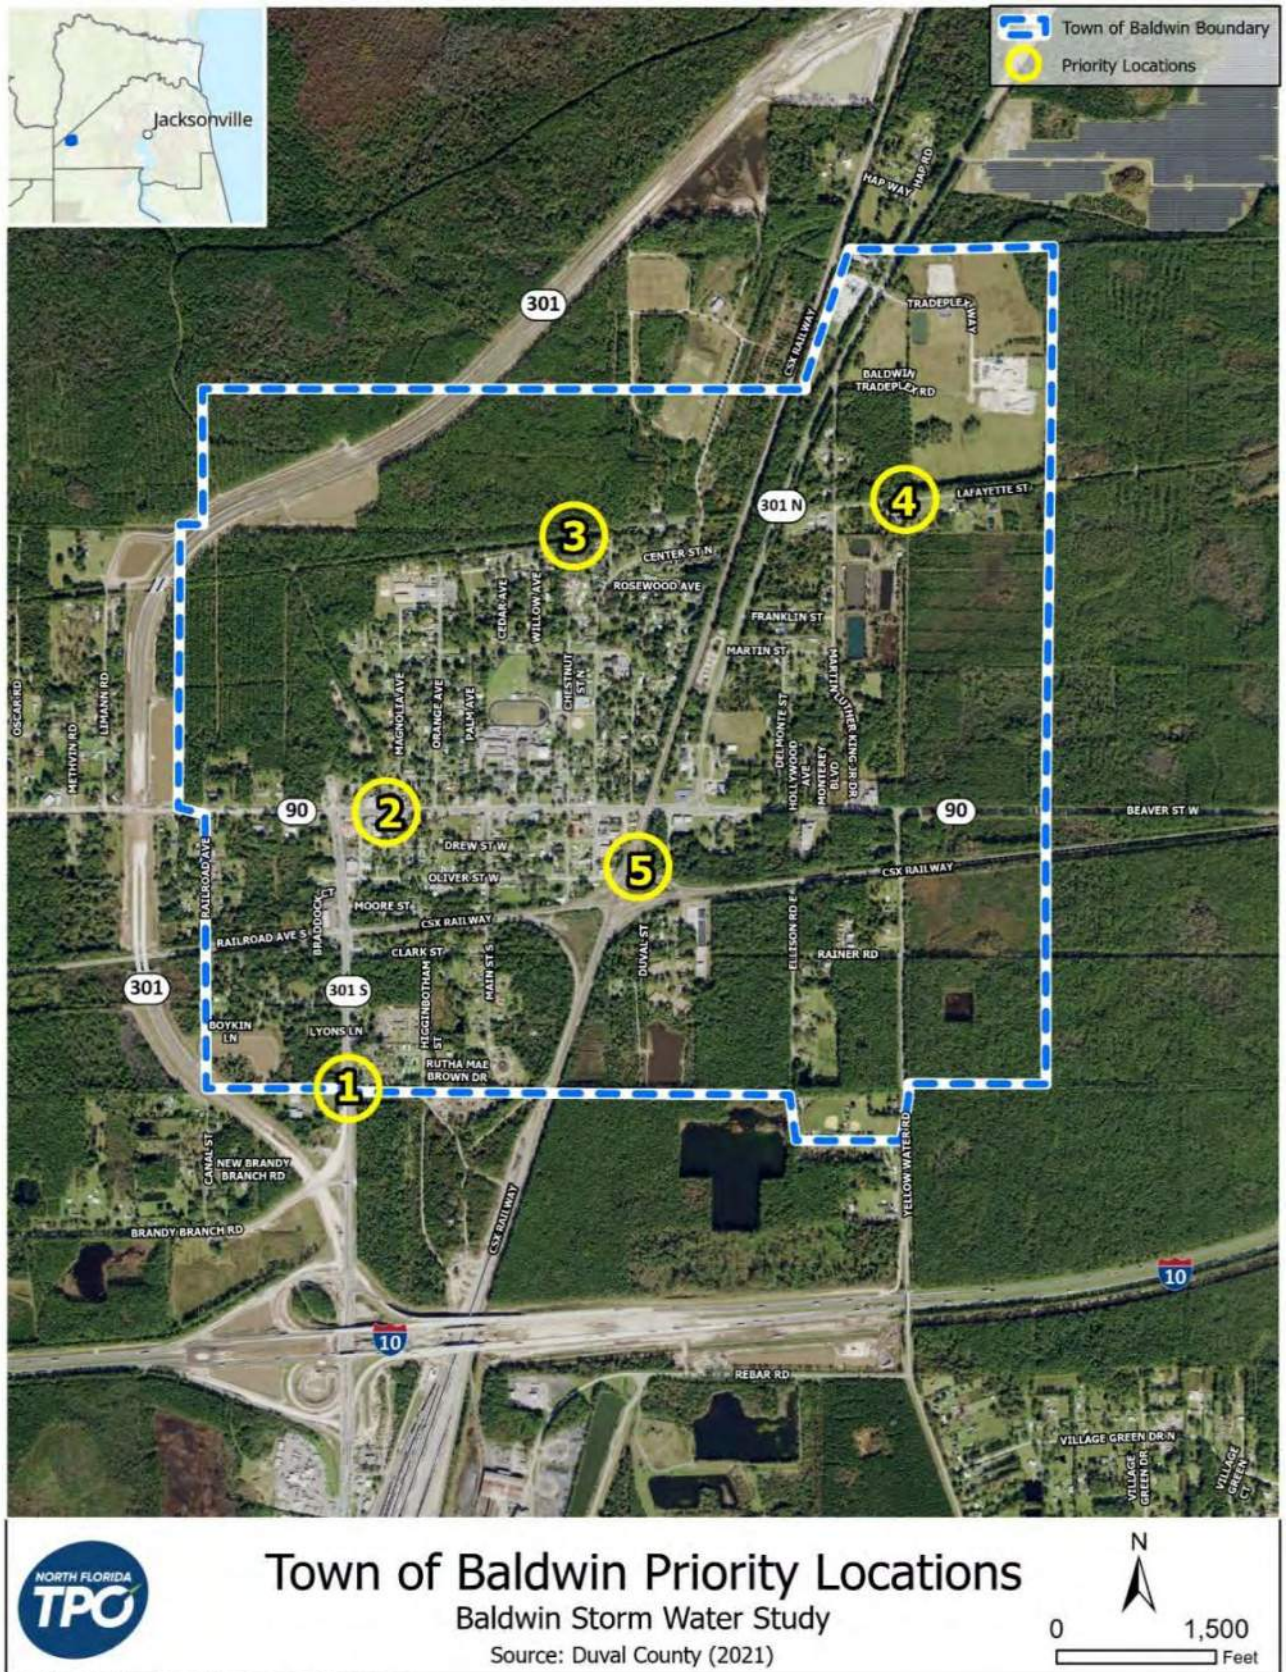
Figure 4. Priority Locations

Priority locations are illustrated in Figures 4 and 5. Figure 5 shows priority locations with problem areas from the public survey. Appendix C-2 includes a priority location map for each type of survey problem area (clogged culvert, ditch obstruction, erosion and flooded roadways).

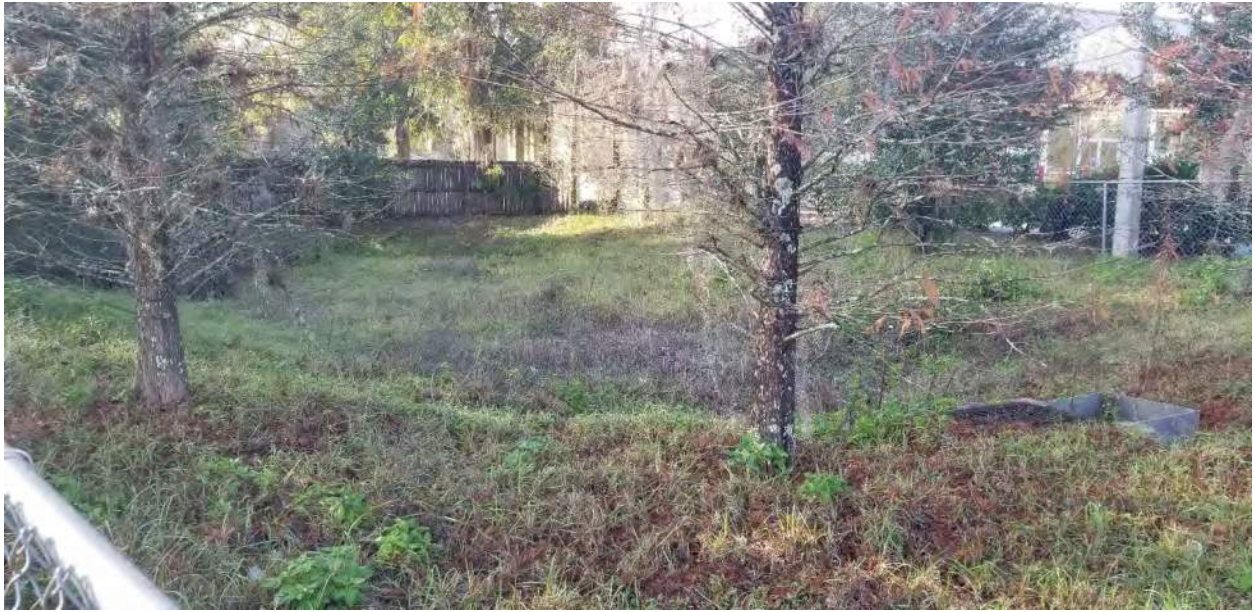
This is a view from the downstream side of the culvert (north side of US 90/ SR 10/ Beaver Street) with the pond in the background.

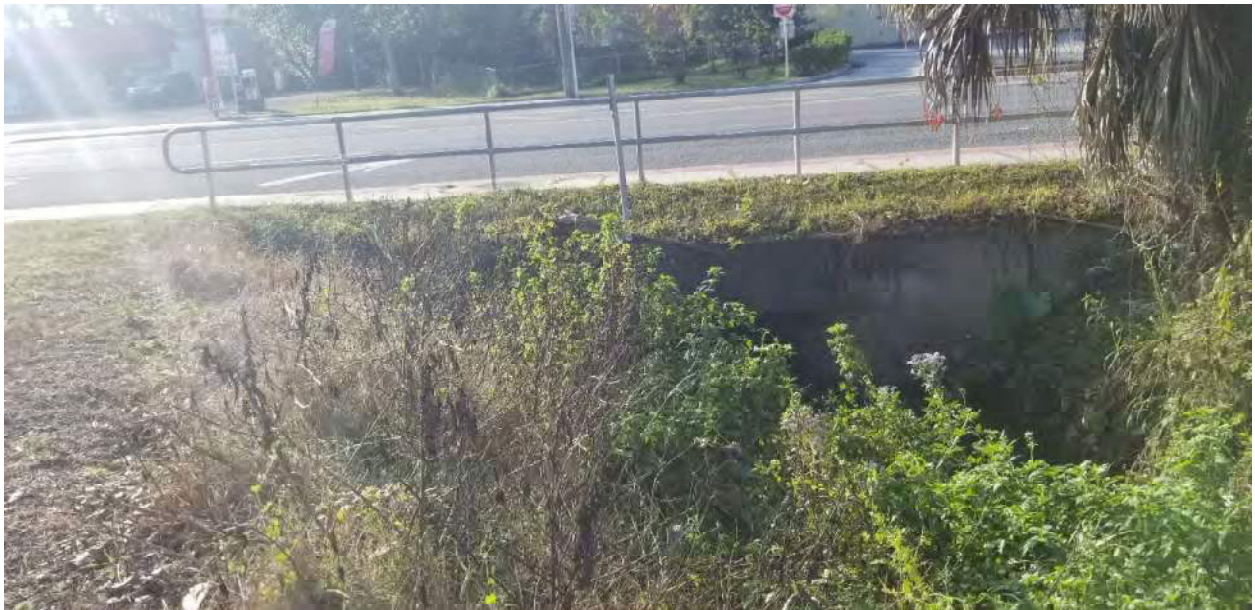
This is a photo of the FDOT drainage structure (culvert inflow) conveying pond outflows and drainage from beyond Drew Street. Here is a view of the channel downstream of the 10-foot by 5-foot culvert.

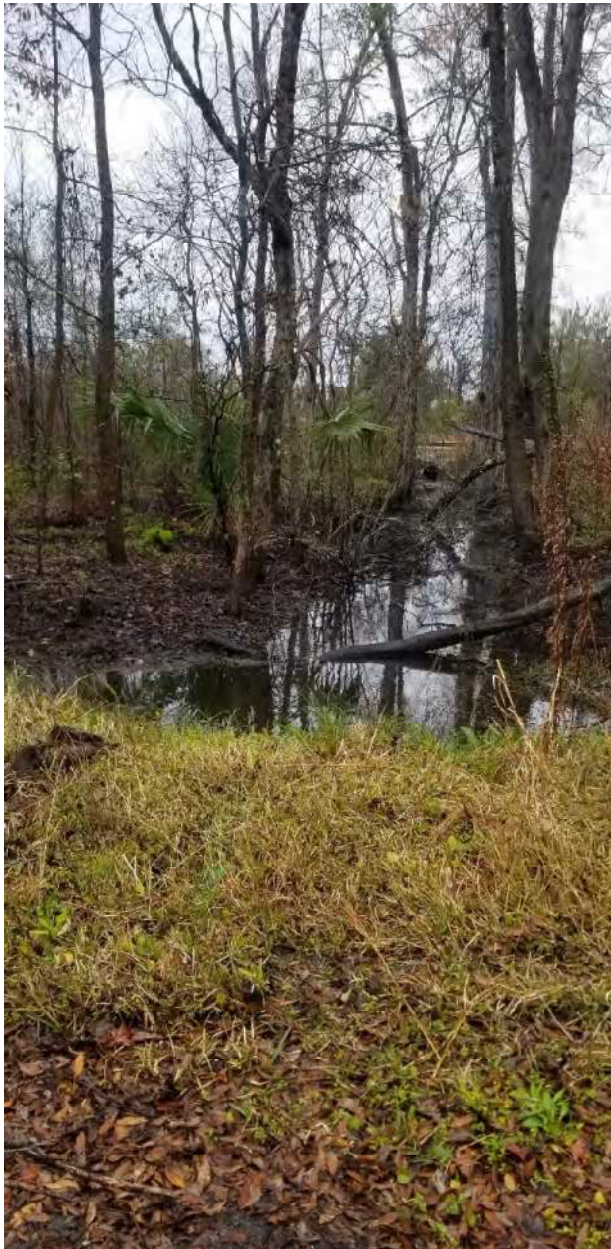
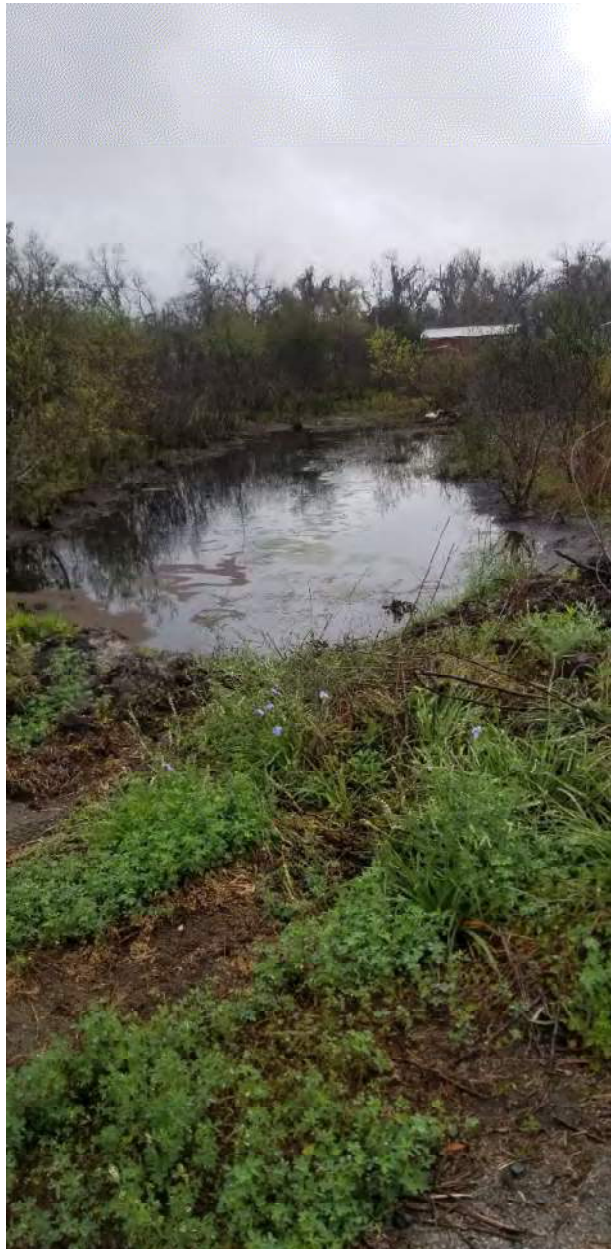
Priority #5

Unmaintained ditches and pond within CSX Railroad right-of-way.
